EXTENDED LOADING OF CRYOGENIC TANKS

C.F. Tiffany , P.M. Lorenz and R.C. Shah

NATIONAL AERONAUTICS AND SPACE ADMINISTRATION
NASA LEWIS RESEARCH CENTER
LIQUID ROCKET TECHNOLOGY BRANCH
CLEVELAND, OHIO

FINAL REPORT

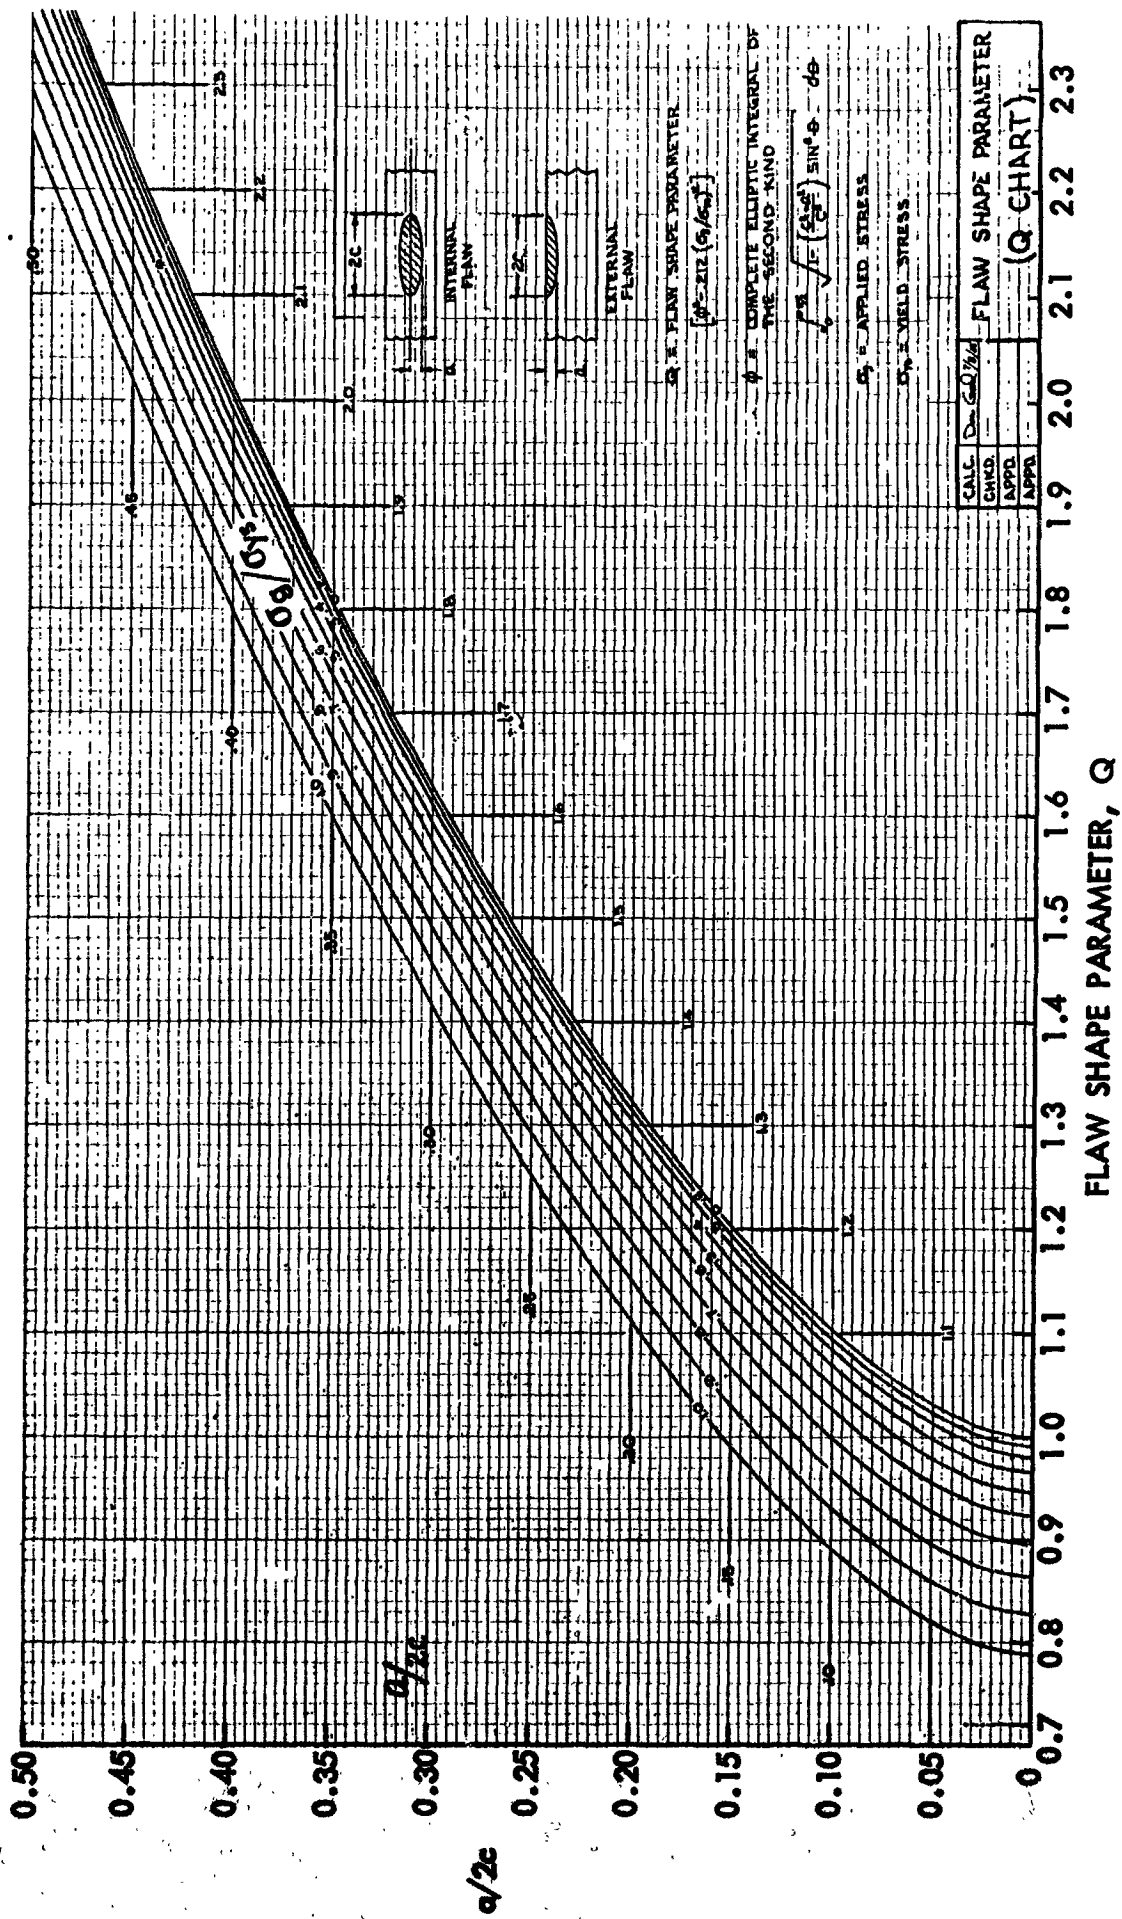
Figure 1 : SHAPE PARAMETER CURVES FOR SURFACE AND INTERNAL FLAWS

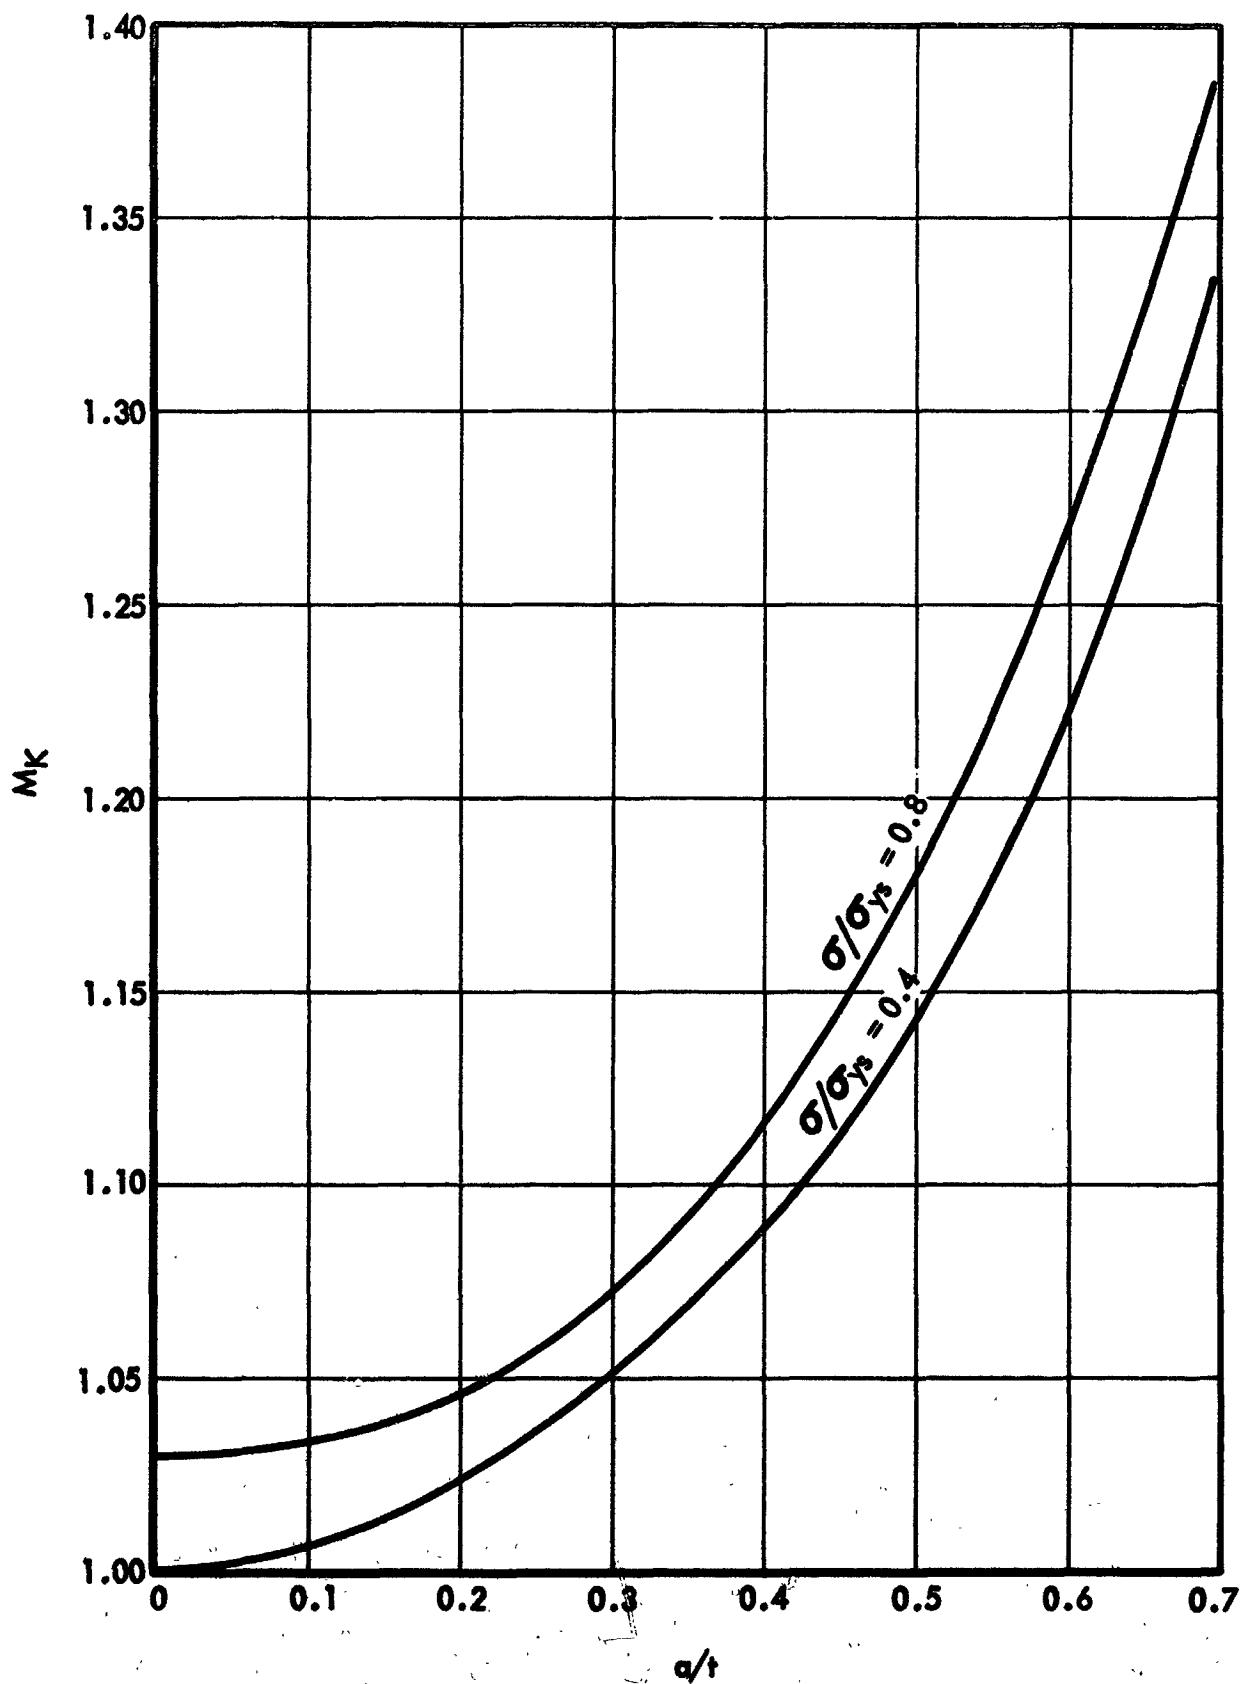
Figure 2 : RESULTANT STRESS MAGNIFICATION DUE TO DEEP FLAW AND PLASTIC YIELDING FOR PLANE STRAIN.
 $\nu = 1/3, a/2c < 0.3$

M_{kf} is the elastic stress magnification due to deep flaw in an infinite strip under the conditions of plane strain.

M_{kp} is the stress magnification due to plastic yielding in an infinite plate under the conditions of plane strain.

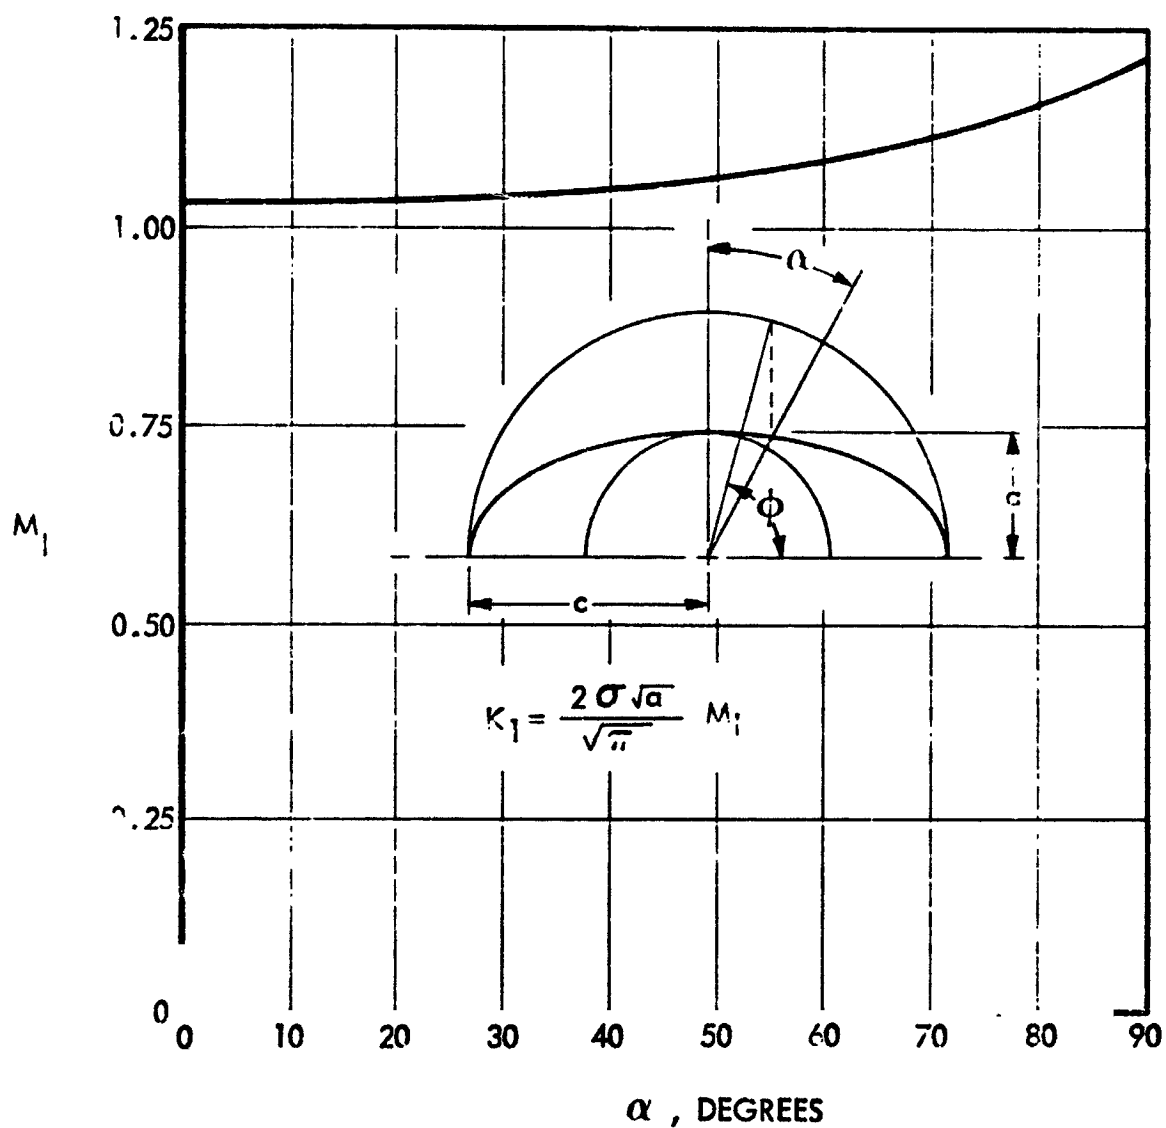
Figure 3 : STRESS INTENSITY FACTOR FOR A SEMI-CIRCULAR SURFACE FLAW

This result corresponds to that shown in equations (1) and (2) except that the 1.1 free surface correction assumed by Irwin is replaced by the M_1 coefficient, which is dependent upon location on the flaw periphery (Figure 3) and plasticity correction is not incorporated. From the figure it can be seen that M_1 varies from about 1.03 at the point of maximum flaw depth to 1.21 at the free surface. Unlike the Irwin equation the point of maximum stress intensity is predicted at the surface rather than at maximum flaw depth. However, for most materials the resistance to fracture is higher at the surface (i.e., higher than the plane strain fracture toughness value), so it is probable that fracture will initiate at a point below the surface where the applied stress intensity becomes tangent to the fracture toughness value. This is illustrated schematically in Figure 4.

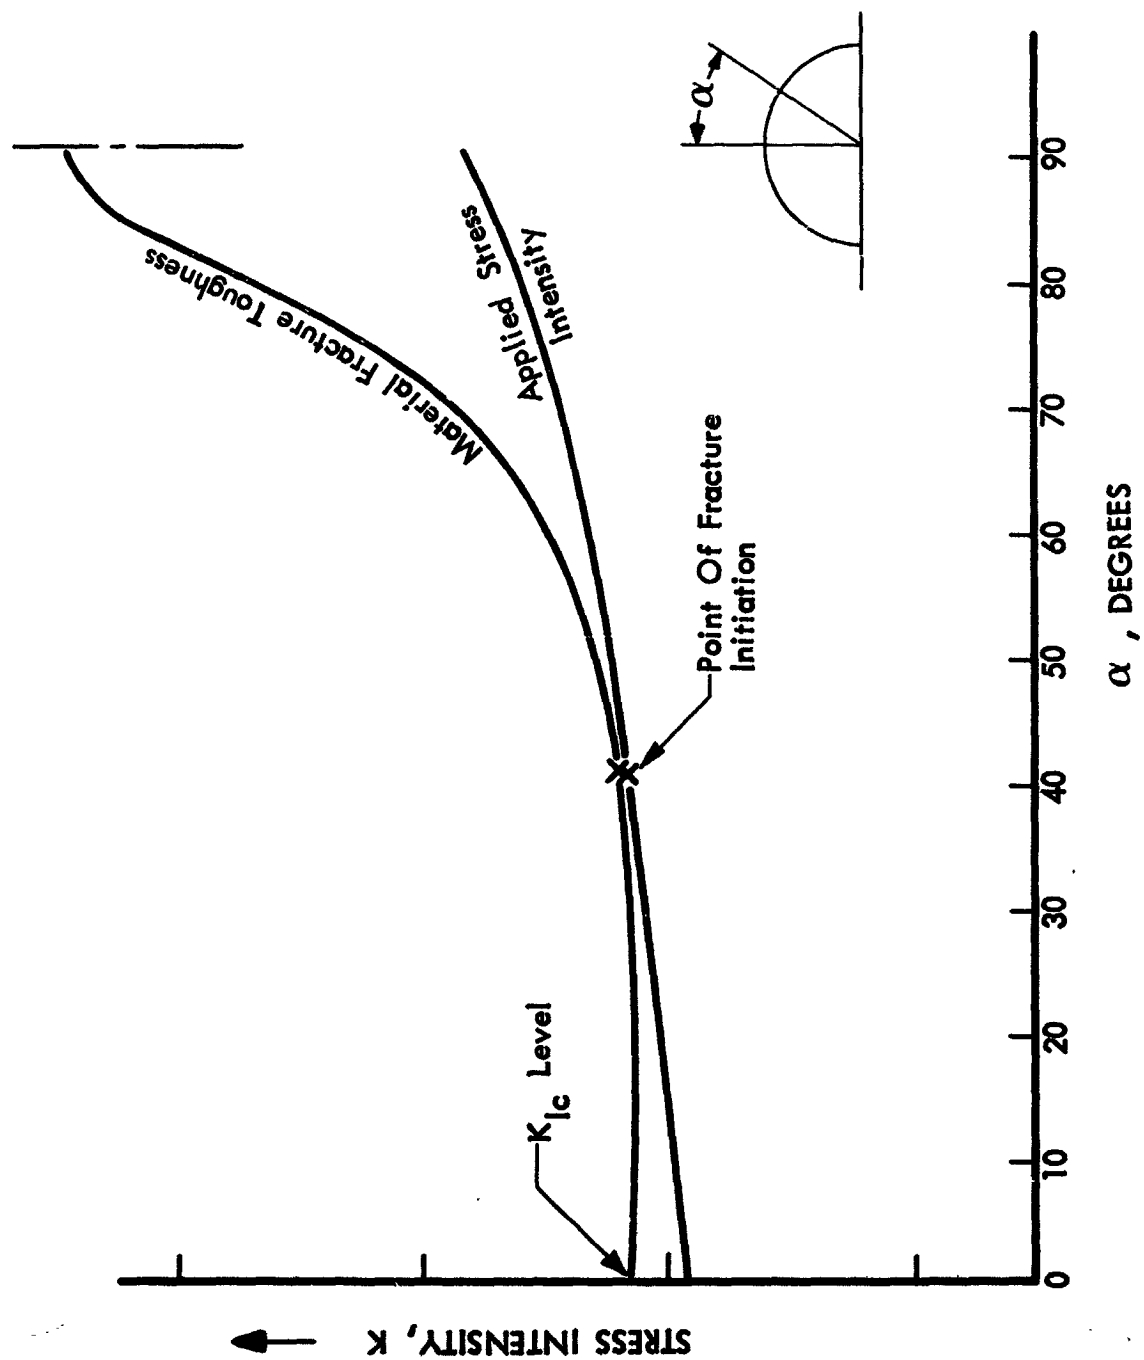
Figure 4 : SCHEMATIC REPRESENTATION OF POSSIBLE FRACTURE INITIATION AT A SEMICIRCULAR SURFACE FLAW

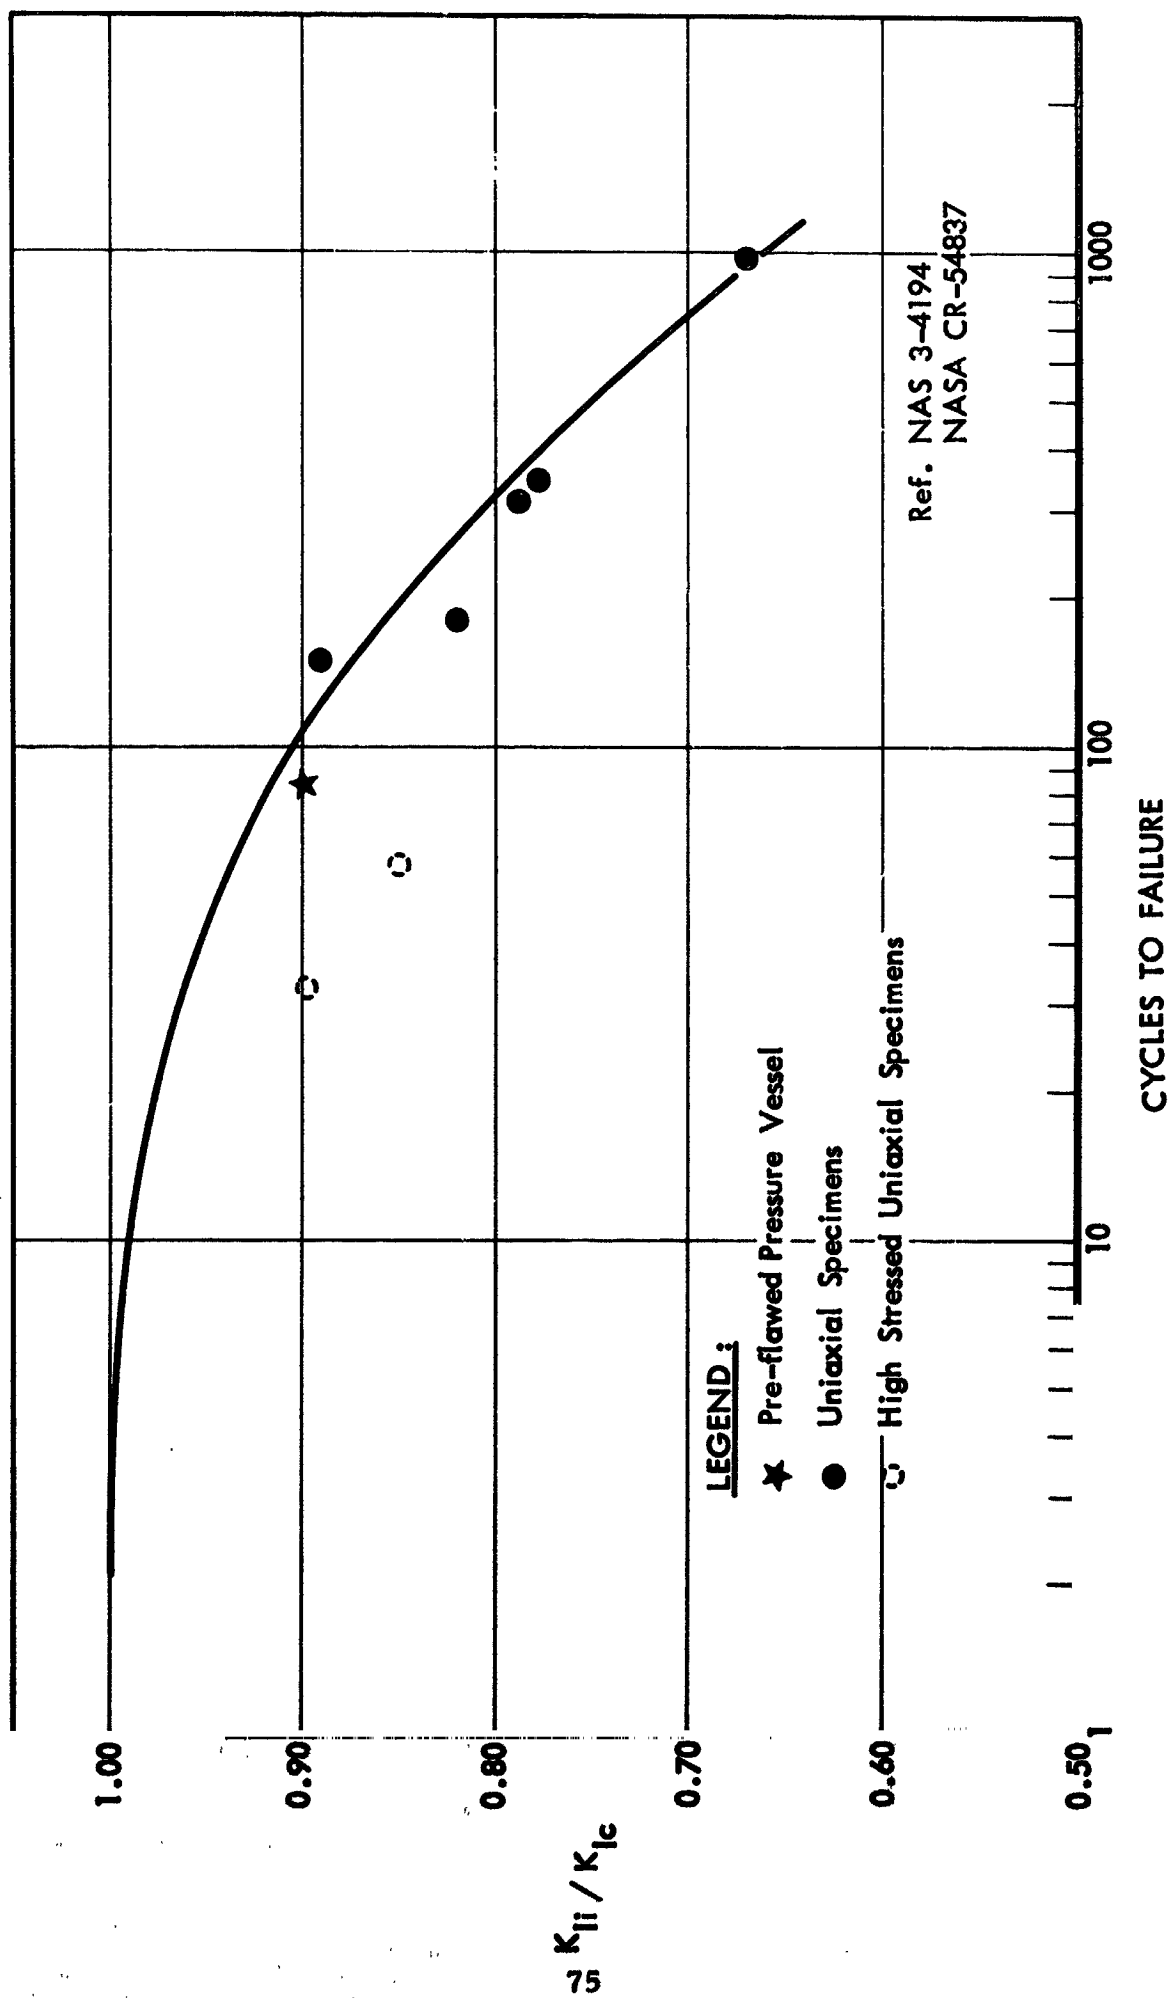
**Figure 7 : CYCLIC LIFE DATA FOR 5 Al-2 1/2 Sn (ELI) TITANIUM
AT -320 OF (0-100-0 Load Profile, 1 CPM)**

Figure 7 shows such a plot for 5Al-2.5Sn(ELI) titanium tested in liquid nitrogen. Several other illustrative and useful ways to plot such data are possible. One is shown in Figure 8. The applicability of this uniaxial fracture specimen data to biaxial stress fields (i. e. pressure vessels) has been demonstrated and the use of the data in predicting pressure vessel cyclic life, determining nondestructive inspection flaw acceptance limits, and selecting design factors presented (1) (2) (8) (9).

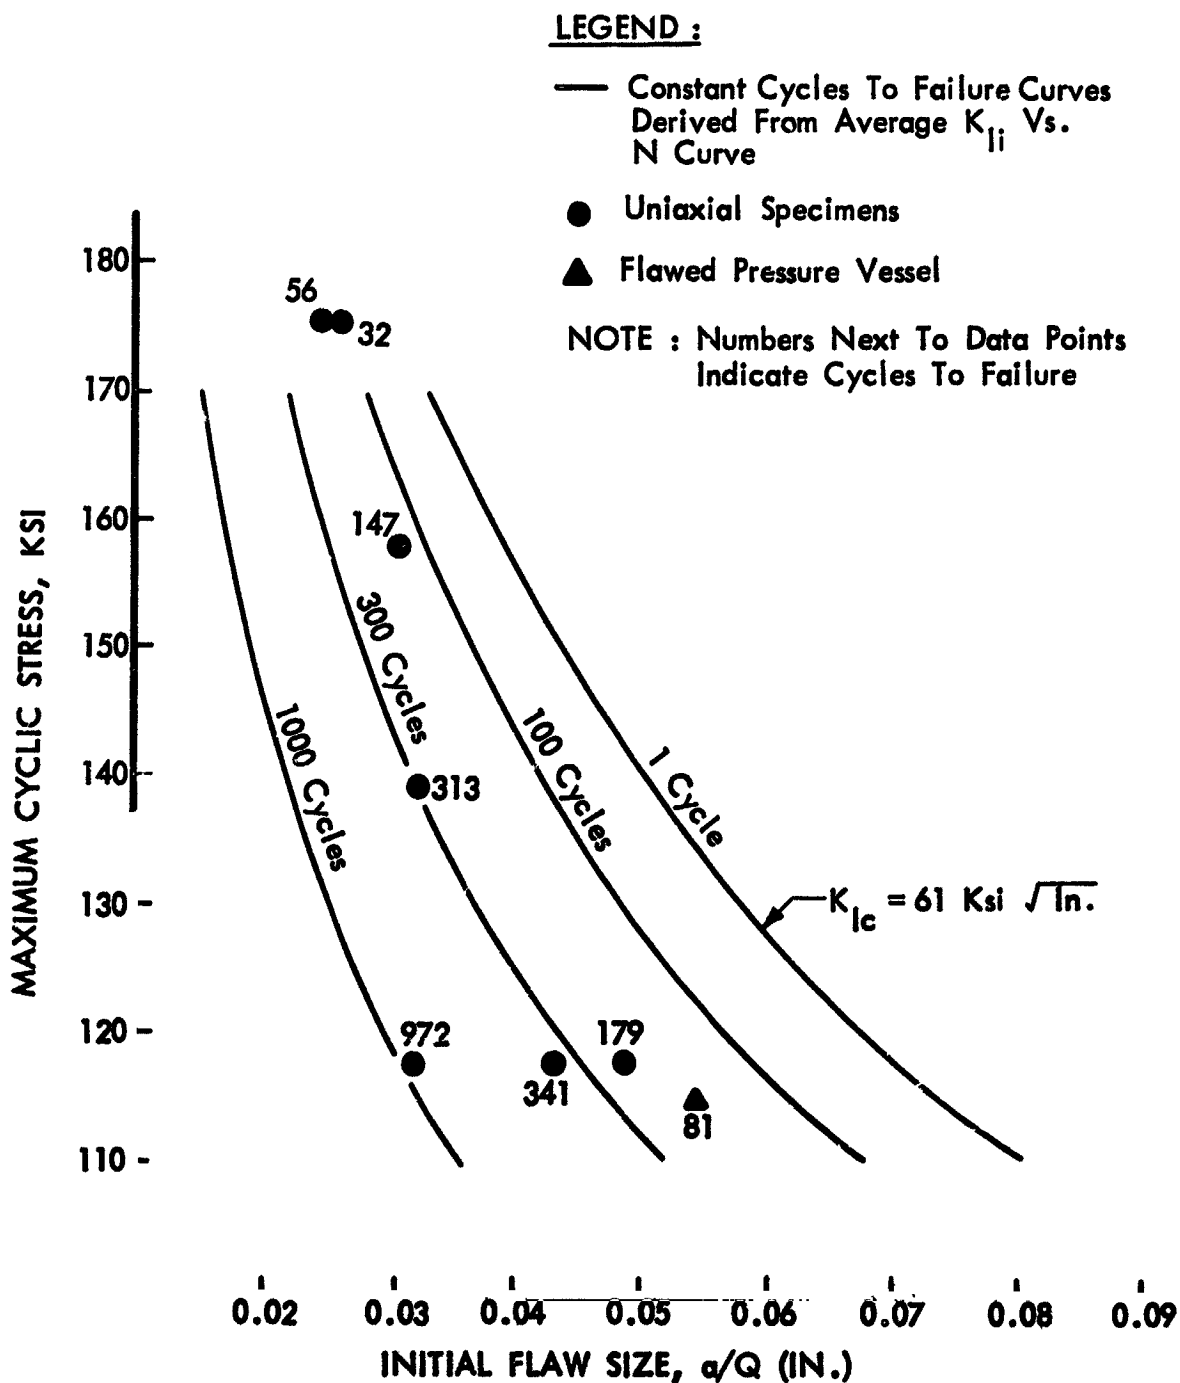
Figure 8 : CYCLIC FLAW GROWTH DATA FOR 5 Al-2 1/2 Sn (ELI) TITANIUM AT -320 °F (0-100-0 Load Profile)

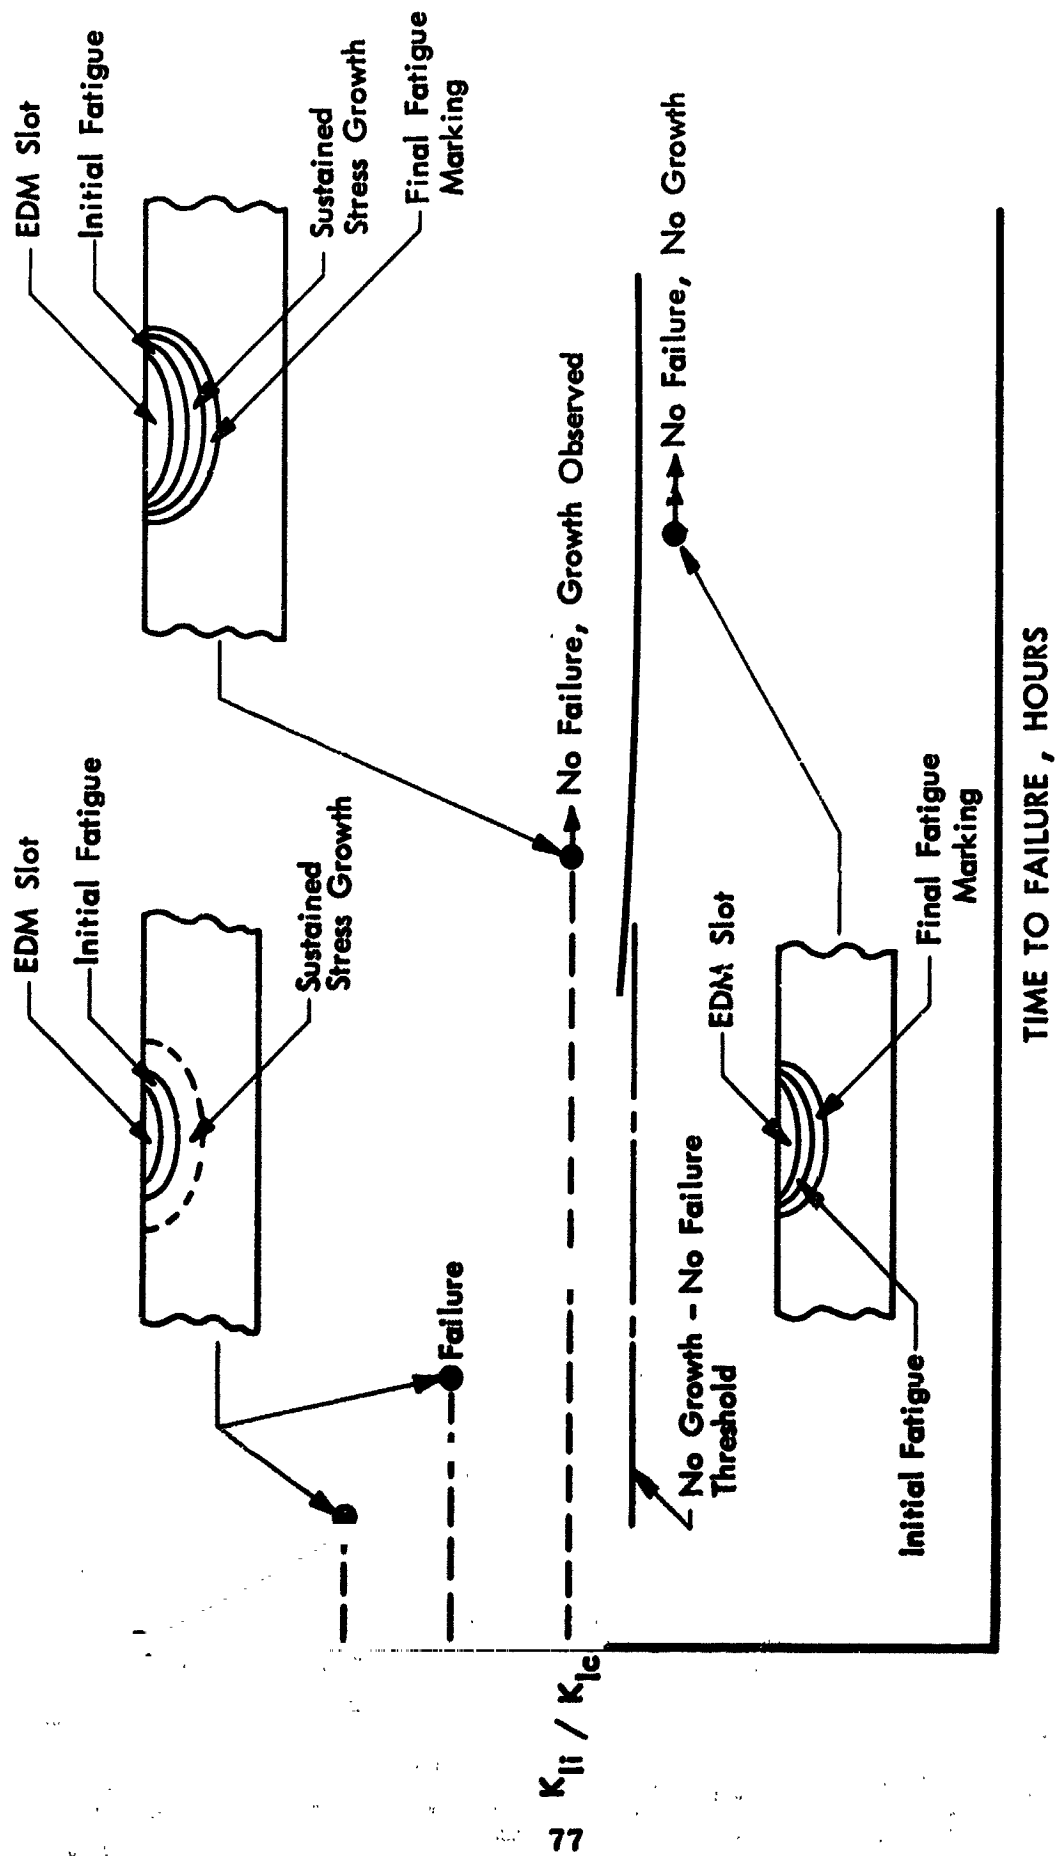
Figure 9 : SUSTAINED STRESS FLAW GROWTH TEST APPROACH

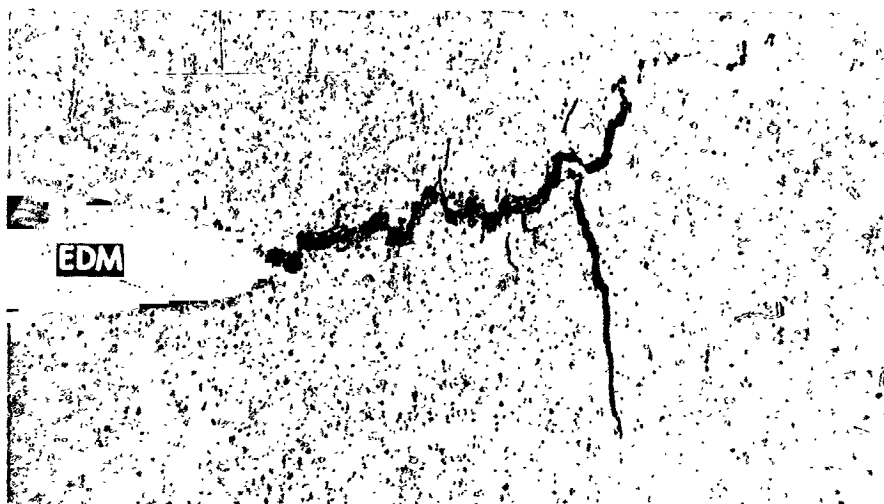
TANK NUMBER 0001
(Second Flaw)

TANK NUMBER 0002
(Second Flaw)

Figure 37: DELAMINATION IN 2219-T87 ALUMINUM TANKS TESTED AT ROOM TEMPERATURE

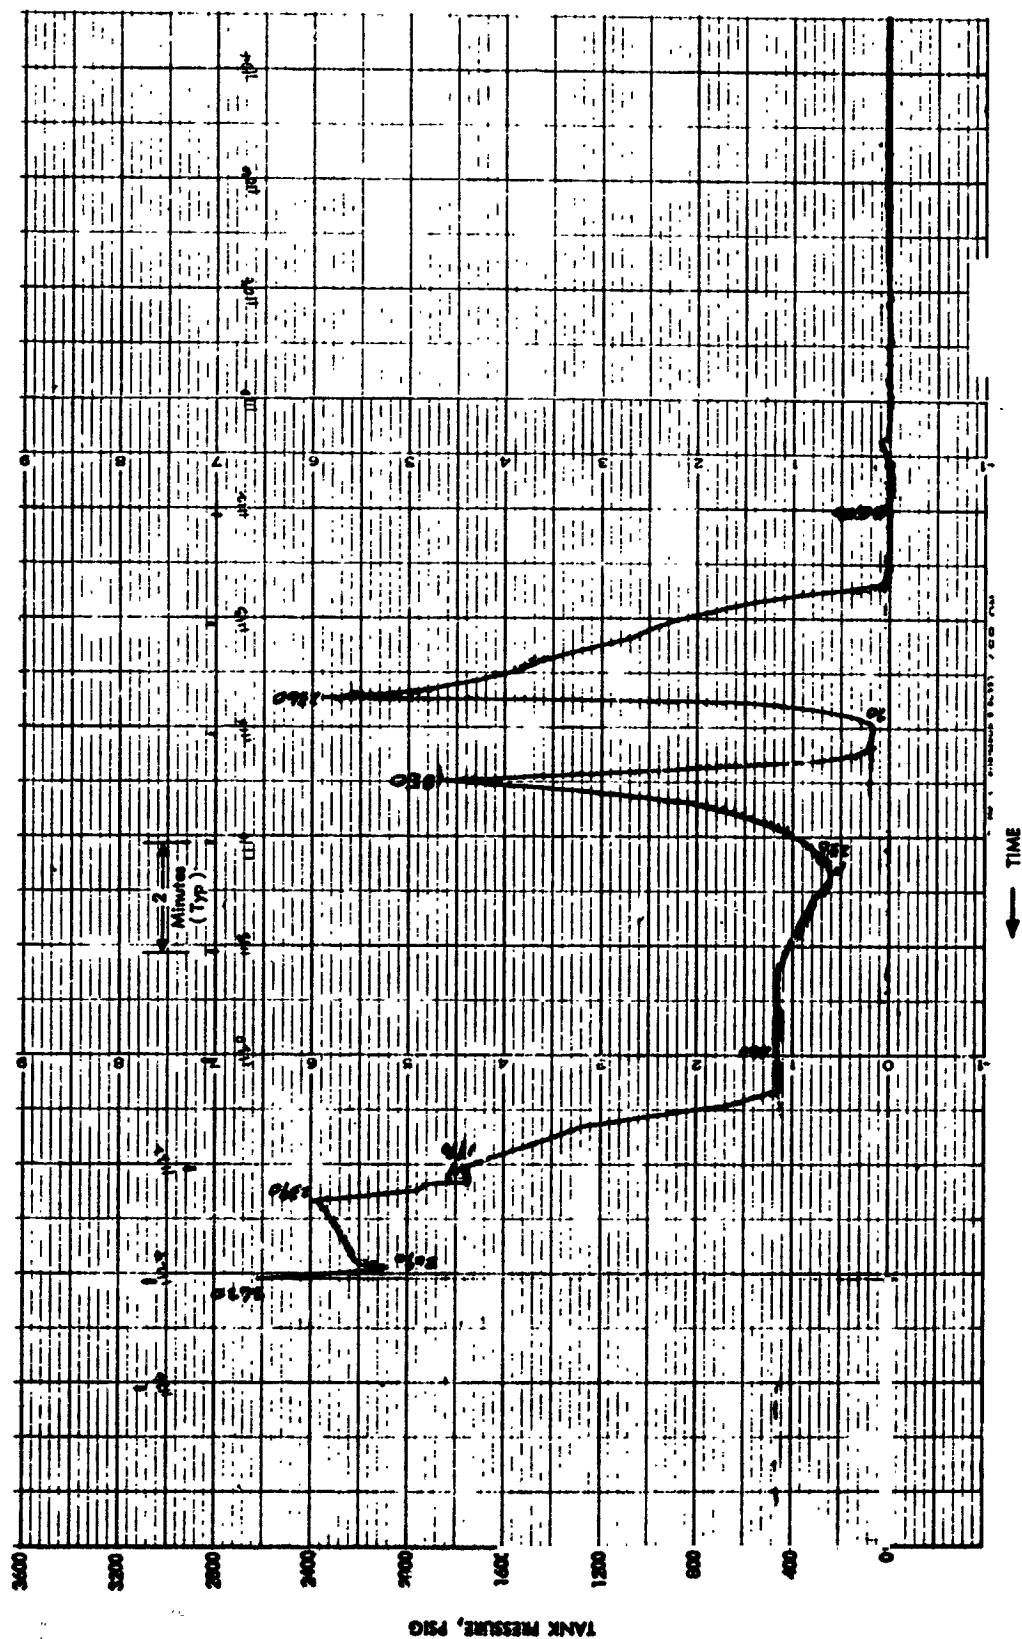
Figure 39: PRESSURE VS TIME CHART RECORD FOR 2219-T87 ALUMINUM TANK
SERIAL NO. 0004 TESTED AT -423 OF

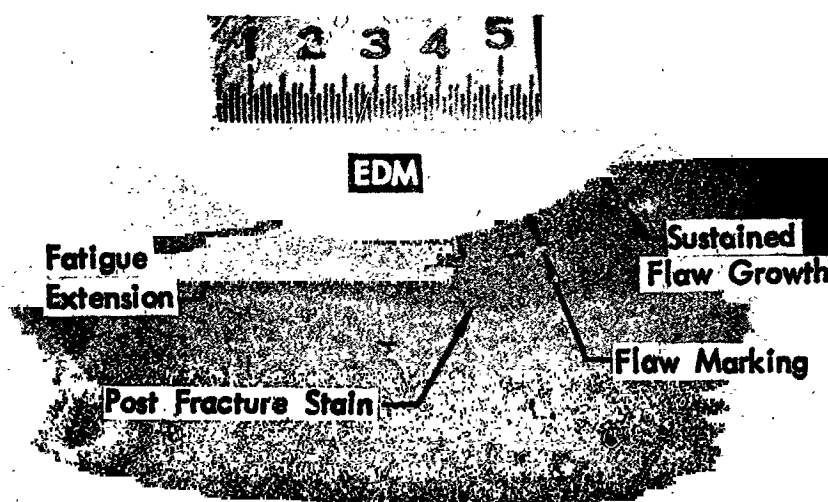
TANK NO. 0002, FLAW NO. 1
(White Light Illumination)

TANK NO. 0002, FLAW NO. 1
(Polarized Light Illumination)

Figure 61: FRACTOGRAPHS OF 2219-T87 ALUMINUM TANK TESTED AT ROOM TEMPERATURE (Tank No. 0002)

Fractographic technique used for flaw size measurement has been developed during the experimental effort sponsored by the NASA Lewis NAS 3-4194 program and essentially consists of illuminating fracture surface with the polarized light.
